## Case Study : In-use stage

### Darlaston Swimming Pool DQI pilot project

Darlaston Swimming Pool is an award winning pool in Walsall , designed by Hodder Associates and consulting engineer Arup and opened in November 2000.

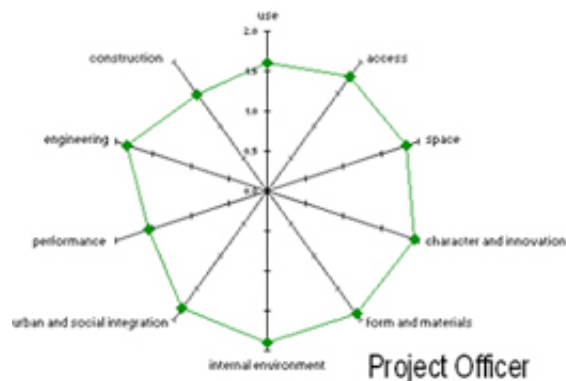
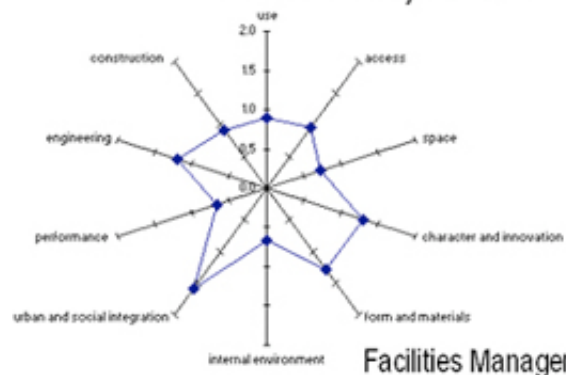
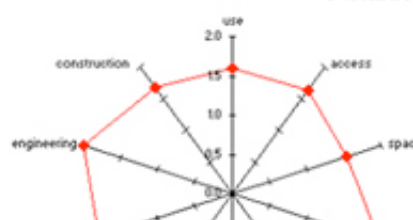
Reassuringly for Walsall council, Darlaston Swimming Pool scores resoundingly well on the most vital aspects of the building's function. According to the three respondents to the DQI questionnaire, the open-plan

building interior works well, easily accommodates the users' needs and enhances the activity of people who use it regularly.
